SOLID PARTICLE EROSION PROCESSES IN
COATINGS AND COMPOSITE MATERIALS

Joseph Zahavi
Israel Institute of Metals
Technion
Haifa, Israel

May 1981

Technical Report for period April 1980 - March 1981

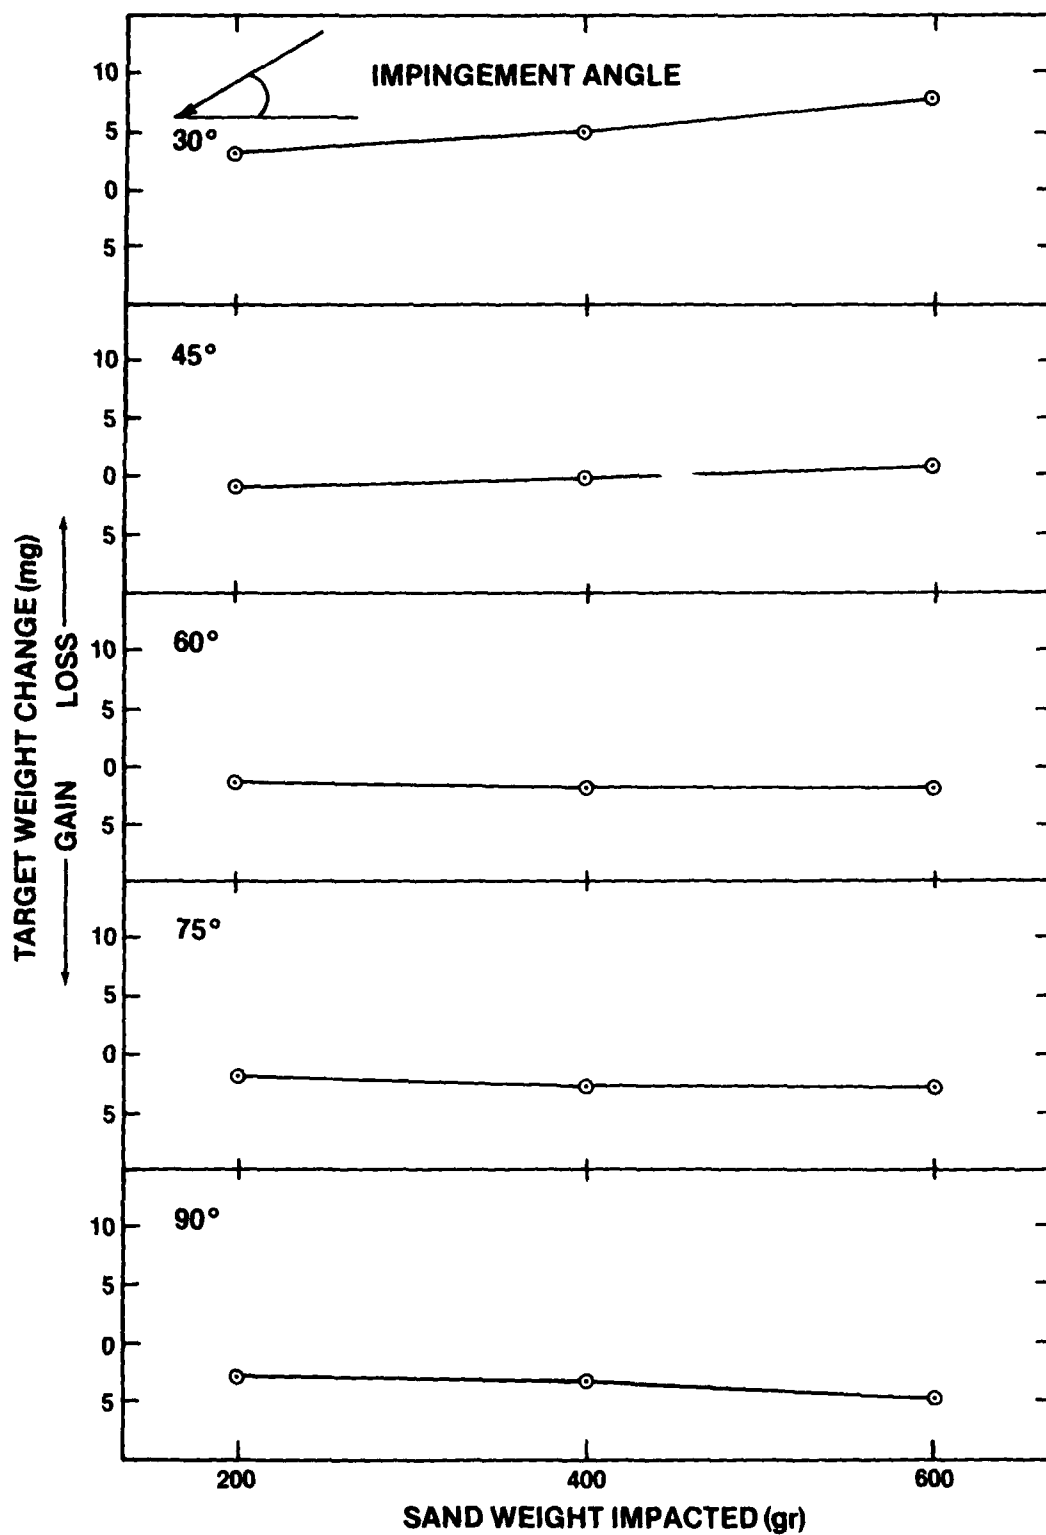
Fig. 3.13 Weight Change of AF-C-VBW-15-15 Fluorocarbon/
Quartz Polyimide as a Function of Sand Weight
Impacted

The behavior of AF-C-VBW-15-15 fluorocarbon coatings on Quartz polyimide substrate was found to be very similar to the MIL-C-83231 polyurethane coating under the same erosion conditions as can be seen in Figure 3.13.

A continuously increasing weight gain of fluorocarbon coatings was found after being exposed to various amount of sand particles (200 gr to 600 gr) at constant impact angles of 45° to 90° . When the impact angle was 30° , a linear correlation between target weight loss and amount of sand impacted was found (Figure 3.13).

Elastomeric coatings materials like polyurethane MIL-C-83231 and fluorocarbon AF-C-VBW-15-15 were also affected by impact angle. For low incident angles of 15° and 30° , target weight loss was maximum but it was reduced to a minimum (near zero) at 30° - 45° . At higher impact angles from 45° to 90° , only weight gain was observed and this was independent of impact angle in the case of the polyurethane material (Figure 3.9 and 3.10). This weight suggests the embedment of sand particle fragments at the target eroded surface. Furthermore, the effect of amount of sand impacted on target weight loss showed that at impact angles in the range 45° to 90° , the target material gained weight rather than lost, independent of amounts of sand weight impacted (Figure 3.12 and 3.13).

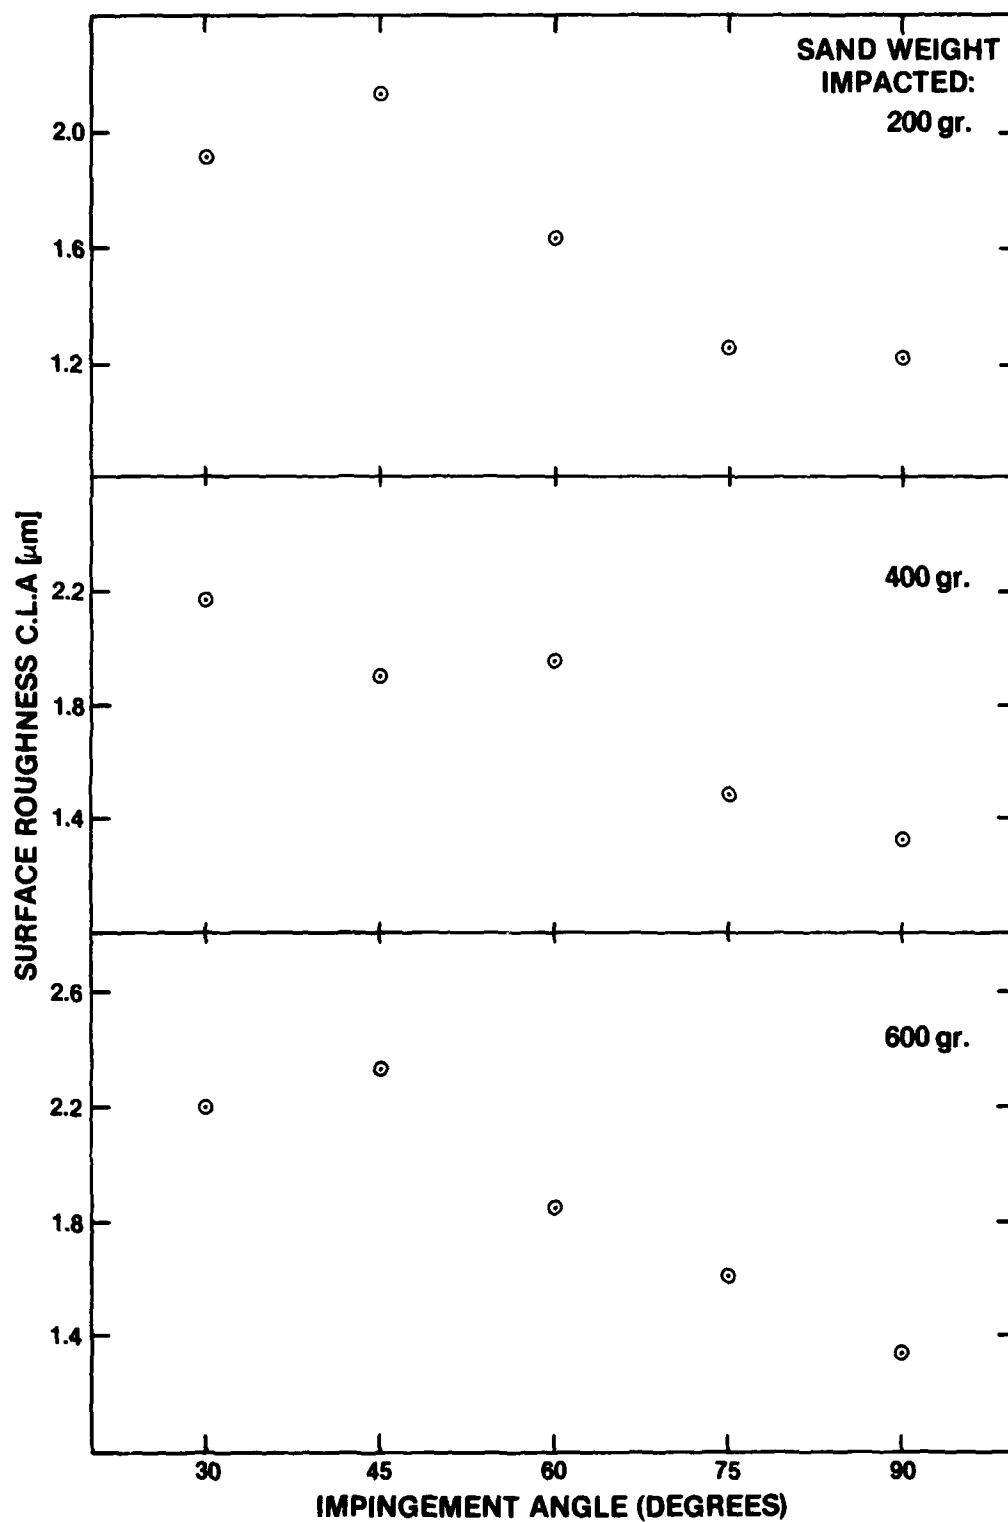
Fig. 3.14 Surface Roughness of MIL-C-83286 Polyurethane as a Function of Impact Angle of Eroding Sand

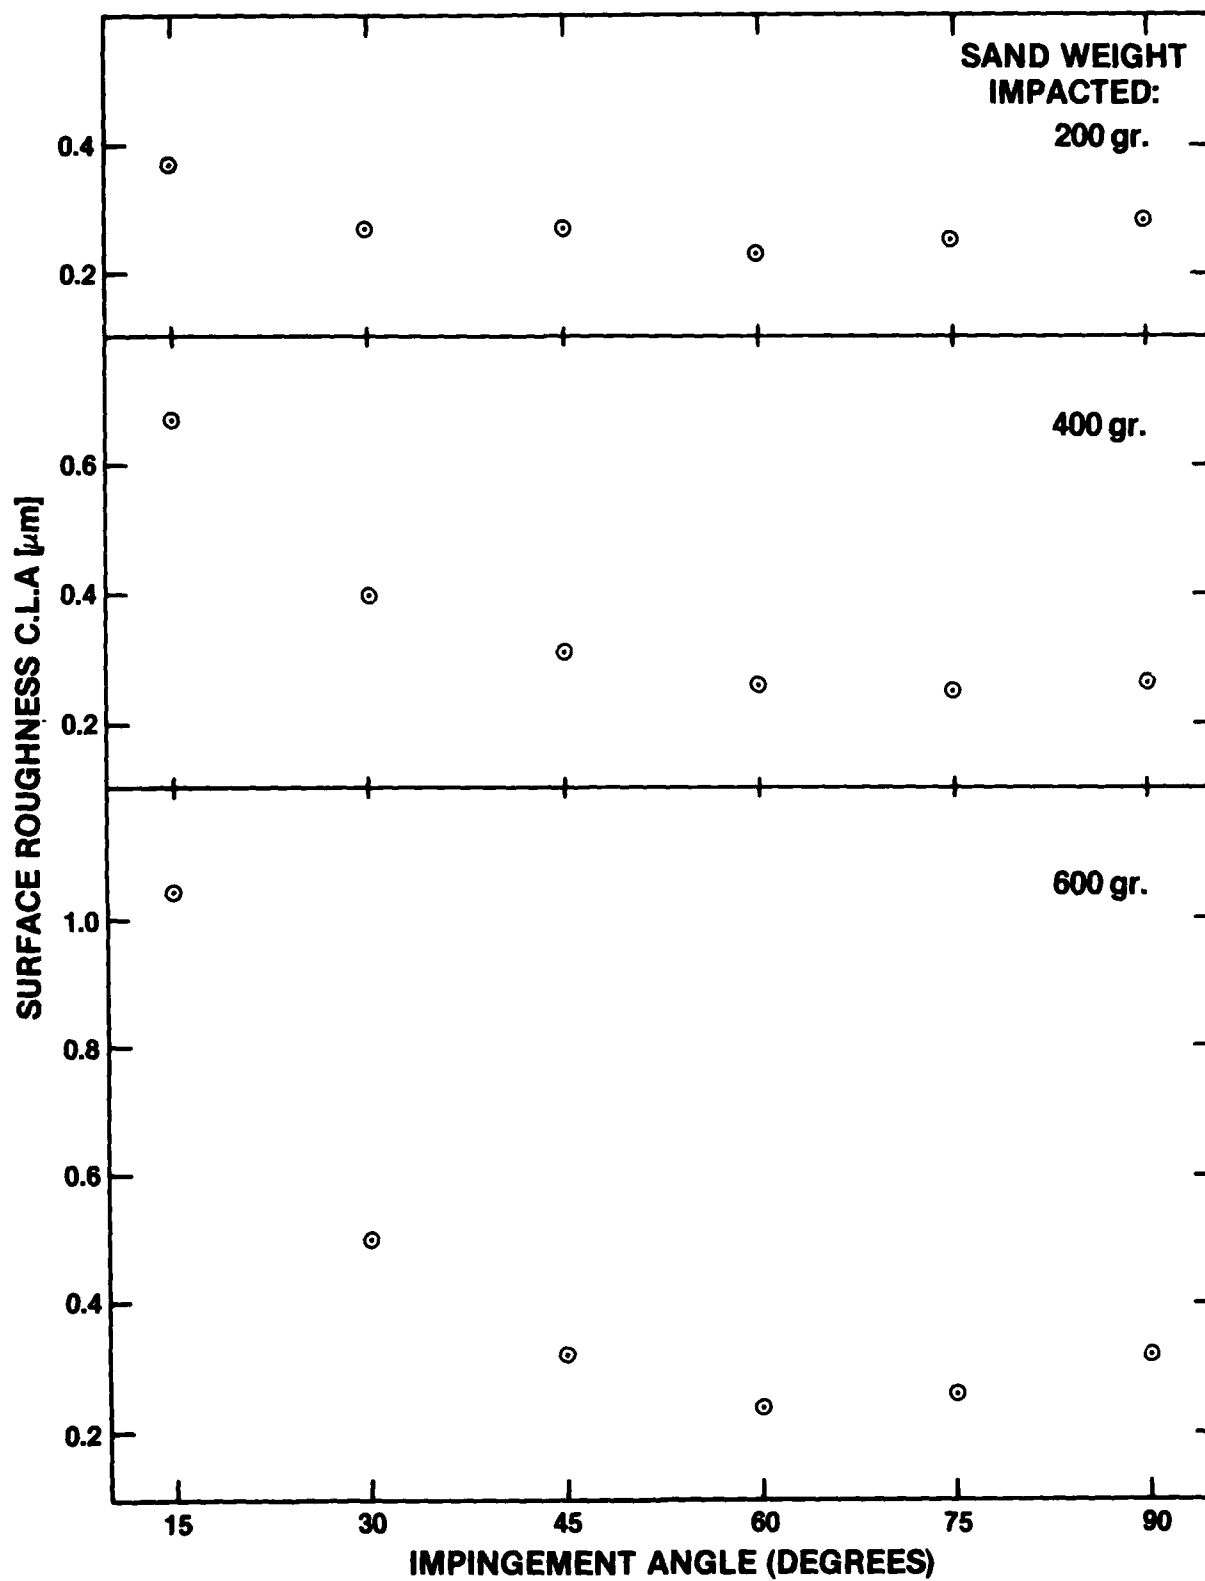
Fig. 3.15 Surface Roughness of MIL-C-83231 Polyurethane as a Function of Impact Angle of Eroding Sand

MIL-C-83231 Polyurethane Coatings. The change of coatings surface roughness with impact angle at various constant amounts of sand impacted are shown in Figure 3.15. Surface roughness was found to decrease from a maximum in the range of 0.4 to 1.0 micron at impact angles of 15° to a constant low values around 0.2 microns at impact angles of 60° to 90° . A profilogram of the surface before and after being exposed to erosion is shown in Figure 3.17.

When erosion rate was found to be negligible at impact angles of 45° to 90° (Figures 3.9, 3.10) the surface roughness was also found to be of minimum value (Figures 3.15, 3.16). These low values of erosion rate together with minimum values of surface roughness are in accordance with the coatings surface morphology. At these conditions no removal of coatings pieces occurred resulted in relative uniform smooth coating surfaces (Figures 3.26B, 3.27, 3.28B).

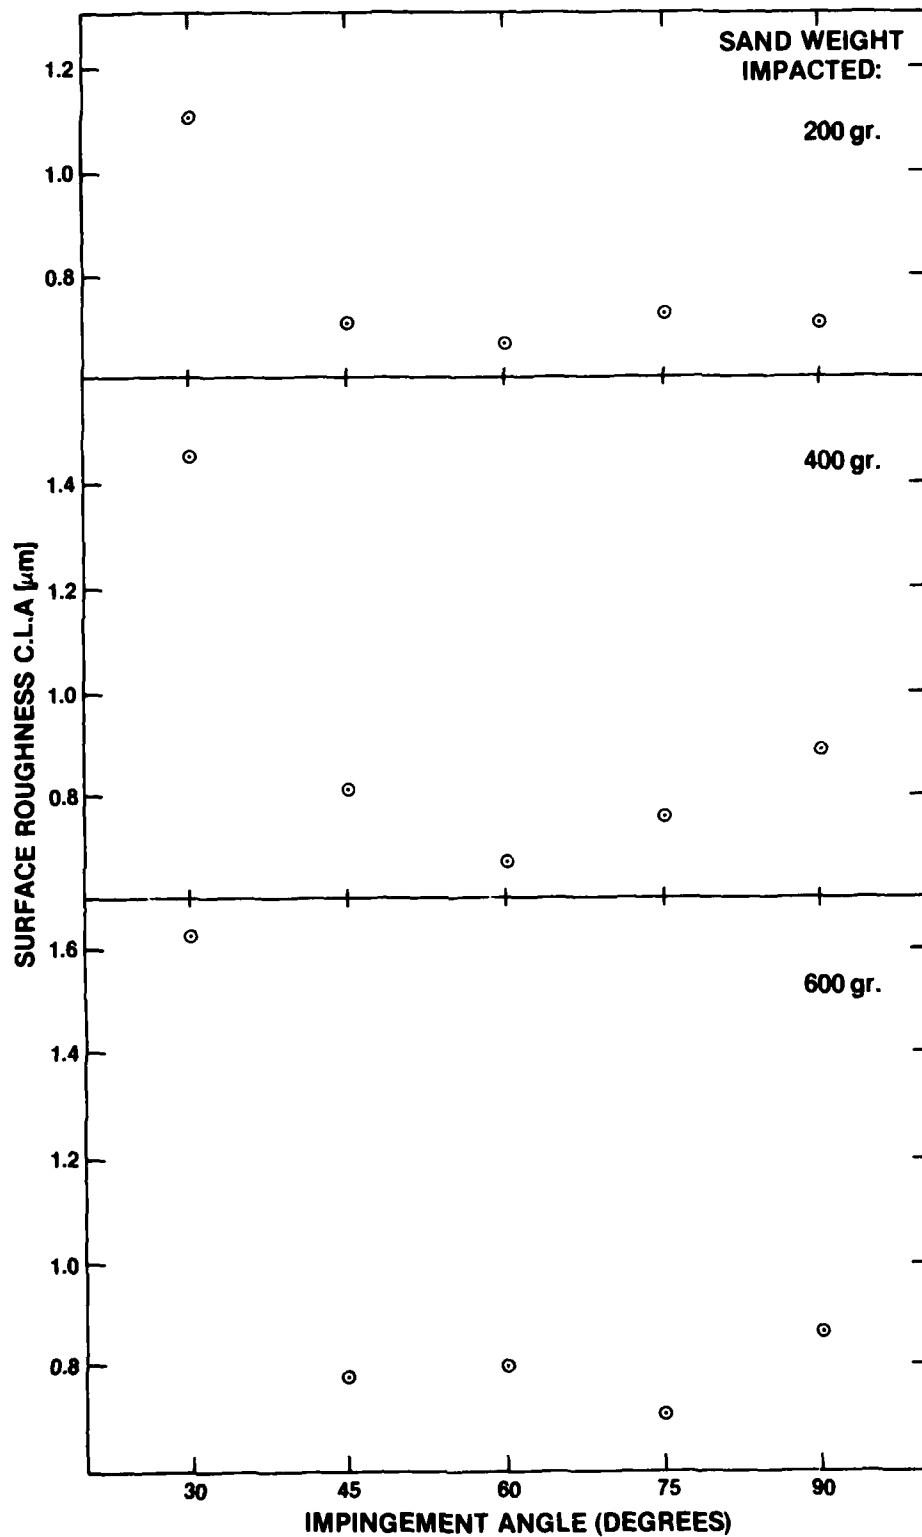
Fig. 3.16 Surface Roughness of AF-C-VBW-15-15 Fluorocarbon as a Function of Impact Angle of Eroding Sand

AF-C-VBW-15-15 Fluorocarbon Coatings. Surface roughness of this coating is correlated versus impingement angles for constant amounts of 200 gr, 400 gr, and 600 gr sand particles impacted. The correlation is shown in Figure 3.16. Maximum surface roughness in the range of 1.0 to 1.6 microns was found at impact angle of 30° for all amounts of sand impacted. A decrease in surface roughness was found with increasing impact angle. A constant low surface roughness value around 0.8 micron was found at impact angles from 45° to 90° (Figure 3.16). It should be noted that the low value of surface roughness of the polyurethane coating was around 0.2 microns compared to 0.8 microns in the fluorocarbon coatings.

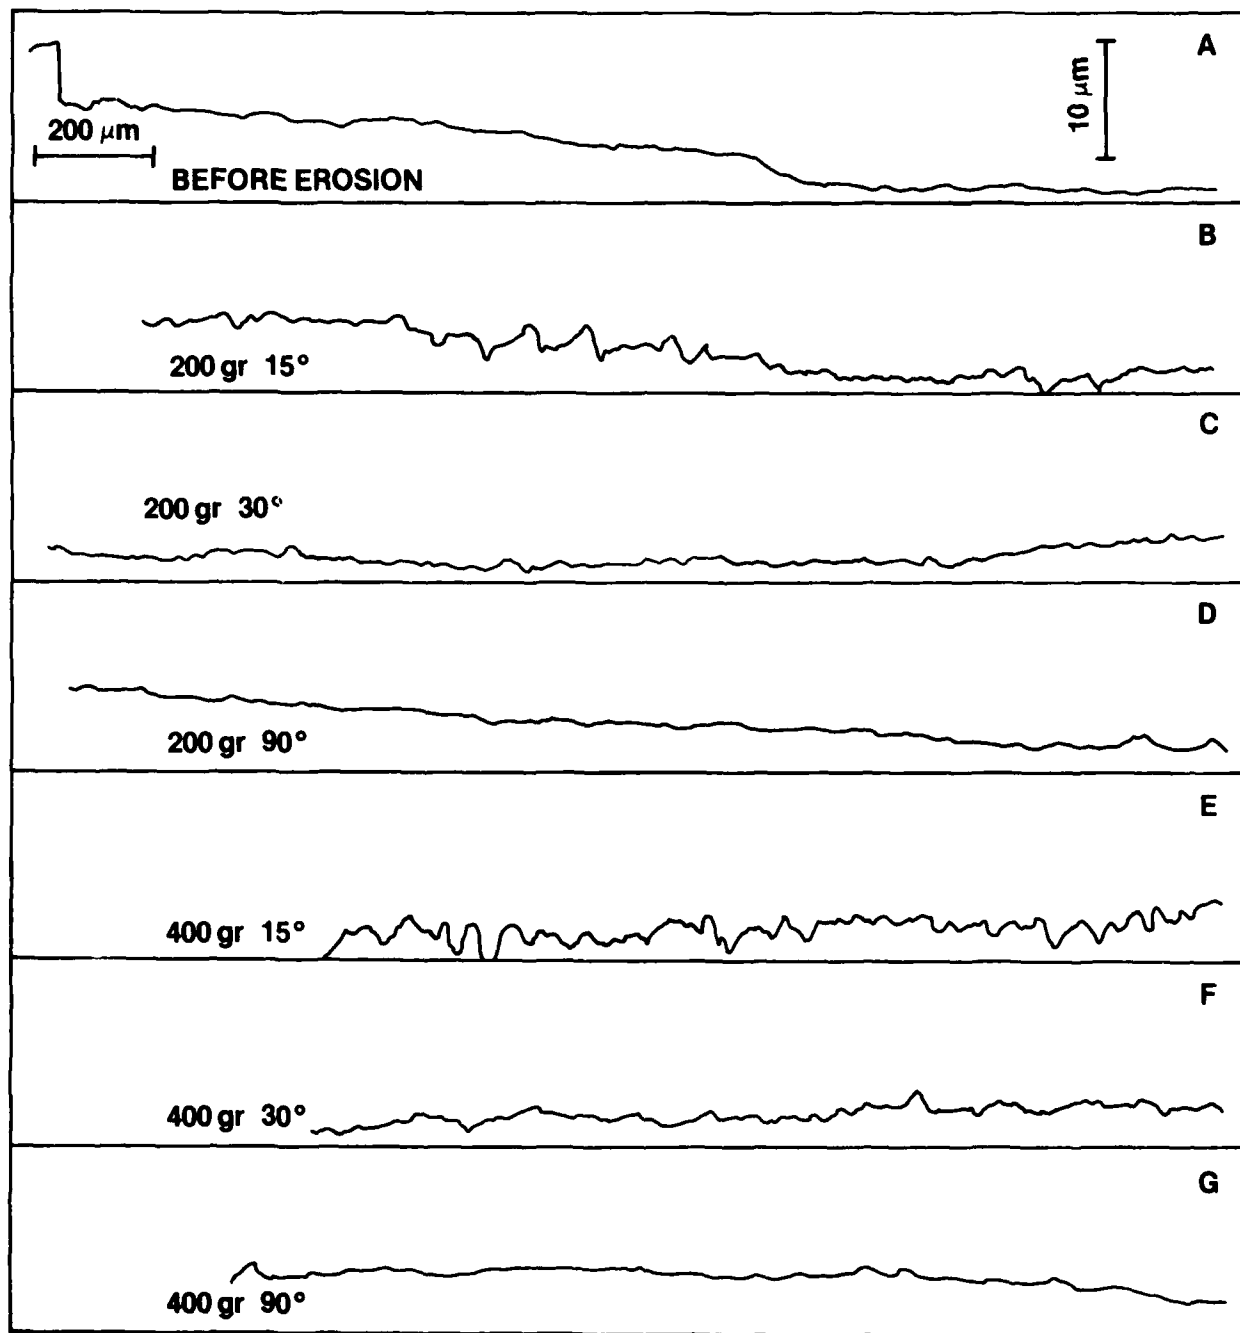
Fig. 3.17 Surface Profilograms for MIL-C-83231 Polyurethane

A rather smooth profile was obtained before erosion, whereas after being exposed to 200 gr and 400 gr sand particles at 10° , a rough profile was obtained with about 5 microns peak to peak and average peak width of 25 microns (Figure 3.17). Increasing the impact angle, led to a smoother surface with lowest profile at 90° . The profilograms exhibited high surface roughness at low incident angle compared to low surface roughness at normal angles.

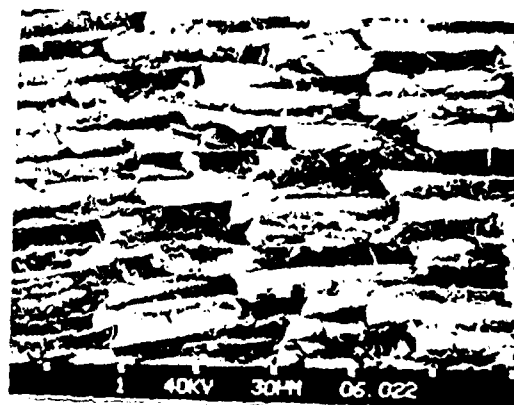
Fig. 3.22 Uncoated Quartz-Polybutadiene after 200 g.
Sand impacted at 30° (500X and 500X)
SEM Micrograph

removal of the epoxy resin material by the erosion process revealed previously unexposed glass fibers which would then be subjected to the erosion process as shown in Figure 3.21B. A typical erosion damage observed in quartz polybutadiene after being exposed to 200 gr sand at 30^0 is shown in Figure 3.22. The morphology of the eroded surface in the polybutadiene resin zone is shown in Figure 3.22A.

Craters and grooves of 30 μm size were observed in the surface indicative of local material removal by erosion process (Figure 3.22A). In the quartz fiber zone, the erosion damage was characterized by broken fibers, removal of fibers fragments which were approximately 10 microns in width and 30 microns in length as shown in Figure 3.22B.

- a) Local removal of resin material from the impacted surface resulted in exposing the fibers themselves to the erosive sand environment (Figure 3.19 for example).
- b) Solid sand particles impacting on the fibers causing their breakage through formation of cracks perpendicular to their length (Figure 3.22 for example).

material removal in the resin area (Figure 3.22), breakage and removal of broken fibers as well as removal of material from the fiber-resin interface zones (Figure 3.21). Differences in the erosion behavior of various types of composite material should be originated from the amount, type and properties of the fibers on one hand and from the type and properties of the resin material and its adhesion to the fibers on the other hand.

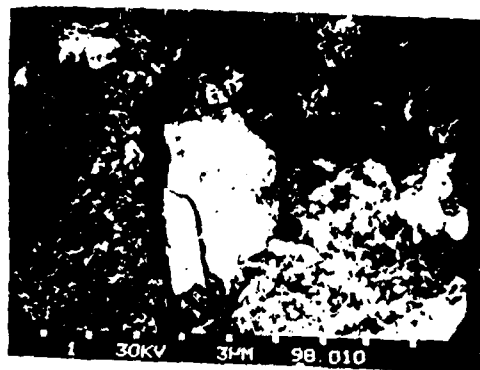
Fig. 3.24 MIL-C-83286 Polyurethane Coating on E Glass Epoxy Substrate after Sand Impact. A) 200g at 90°, B) 200g. at 30°, C) 600 g. at 90° (1000X, 600X, and 3000X)
SEM Micrograph

A detailed picture of local erosion processes can be seen in Figure 3.24 for impact sand amounts of 200 gr, 600 gr at impact angles of 30° and 90°. Figure 3.24A shows that local material removal was associated with formation of cracks, crack propagation and intersection which resulted in removal of fragments of coatings materials in the range up to 10 microns. Moreover, these local erosion processes at normal

A crater formed by sand impacted at 30° angle on coating surface is shown in Figure 3.24B. The damage consists of several elongated craters around 30 microns in size. Also a fragment of a sand particle was found in the middle of the eroded area (Figure 3.24B).

coatings and the substrate. However, it was also dependent on the impact angle. At normal impact angle, the final removal rate was very low (Figures 3.28B, 3.28D, 3.24A) compared to high rate removal at low impact angles (Figures 3.24B, 3.25B, 3.26A). Also, it might be noted that at low impact angles, the removal of coatings material resulted in local elongated type craters or cavities at the eroded surface (Figure 3.25B).

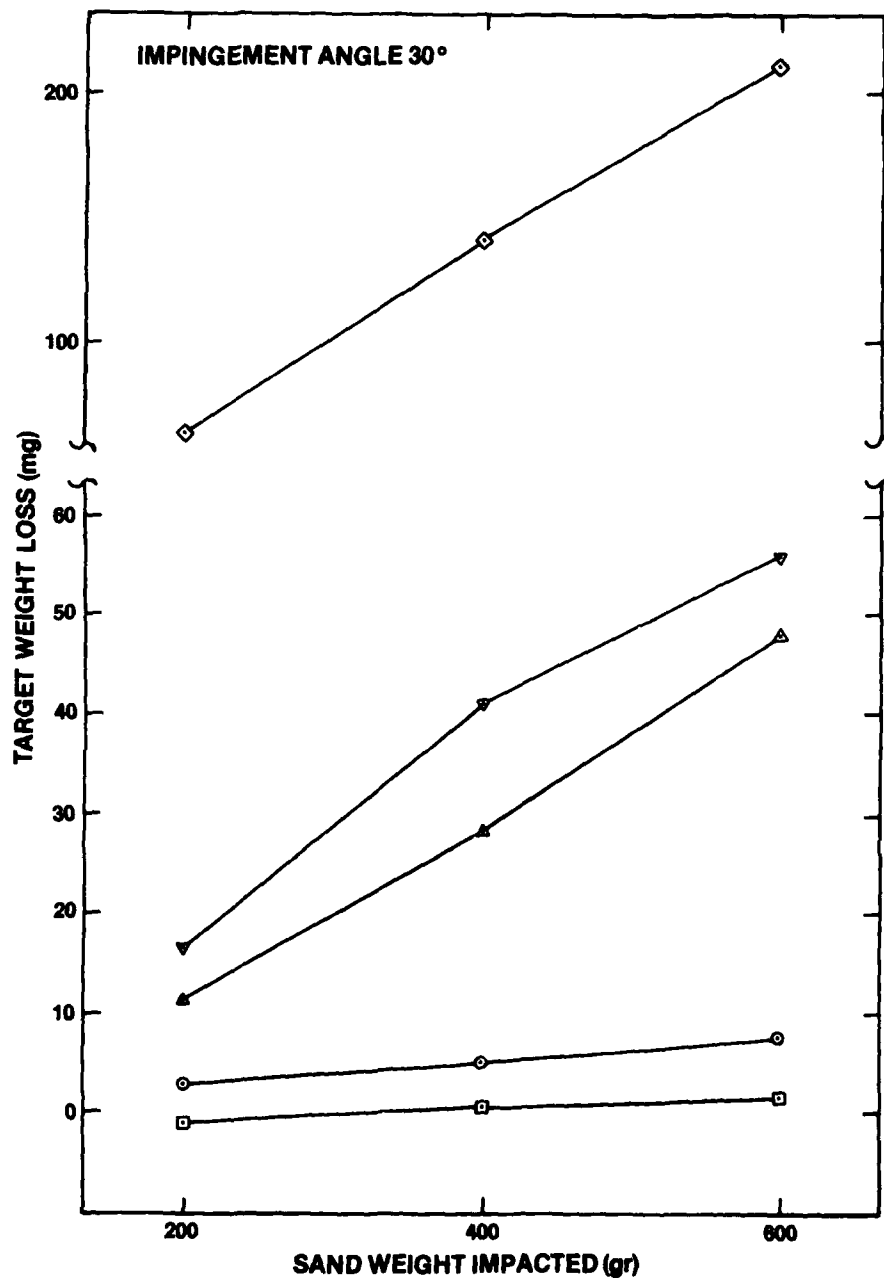
Fig. 4.1 Target Weight Change as Function of Sand Weight Impacted at constant impact angle of 30°.

A comparison of uncoated E Glass-Epoxy and MIL-C-83286 and MIL-C-83231 Polyurethane coated E Glass-Epoxy and of uncoated Quartz-polyimide and AF-C-VBW-15-15 Fluorocarbon-coated Quartz-polyimide is shown in Figure 4.1 as a function of sand impacted at 30° angle. Note that the

Quartz-polyimide erosion is an order of magnitude greater than the E-Glass Epoxy and that the fluorocarbon erodes slightly more than the polyurethane. Figure 4.2 makes the same comparisons at a 90° angle with similar relative performance for the materials. In every case, the ability of these elastomeric coatings to protect the composite substrates is demonstrated. The erosion mass loss of the uncoated composites and the MIL-C-83286 Polyurethane increase similarly while the erosion of the elastomeric coatings is almost independent of sand weight impacted.

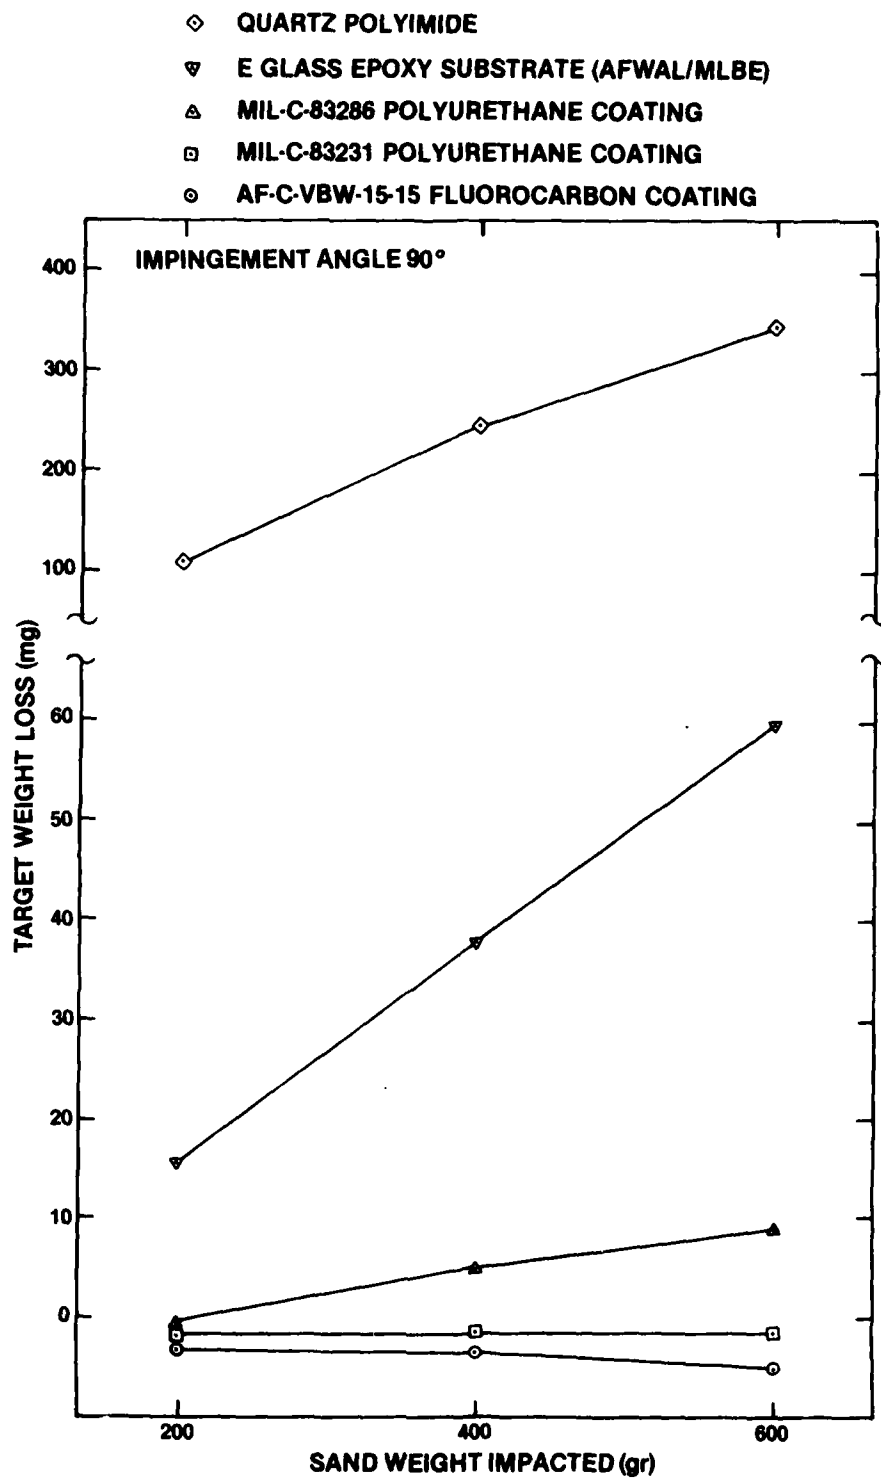
Fig. 4.2 Target Weight Change as Function of Sand Weight Impacted at constant normal impact angle.
